Murray's Boat Disengaging Gear

By Bob Read, D.M.D.

(Revised 7/18/2018)

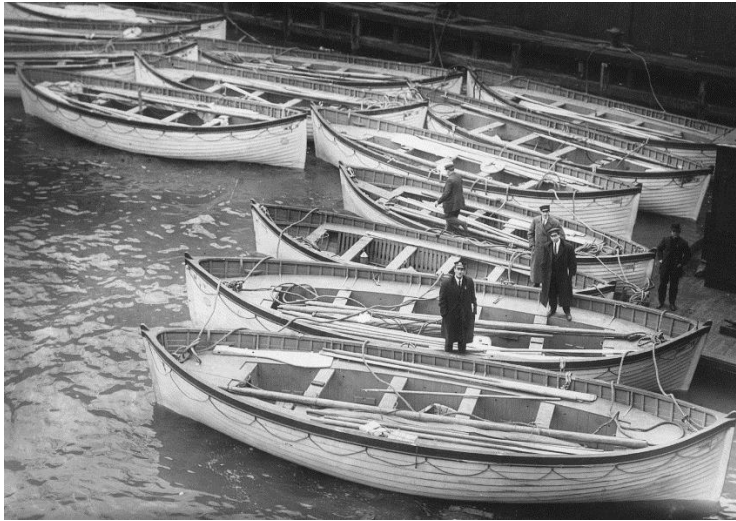
Figure 1

The few photos we have of the Murray's gear have had to be mined to discover most of what we know about the actual appearance of the device. The primary photo which has yielded the most information is a photo of Titanic's lifeboats post-disaster tied up at the dock in New York after they had been returned by R.M.S. Carpathia (Figure 1).

In examining enlarged areas of this photo, we find that there are some inconsistencies in the appearance of the devices. The inconsistencies are really apparent between the gear found on the 30 ft. main lifeboats and the 25 ft. emergency cutters. These differences will be discussed later. The next image is probably the best of the device as seen in a 30 ft. lifeboat (Figure 2).

One of the problems with the images in the master photo (Figure 1) is that there are other items of boat equipment which obstruct a clear view of the gear. The appearance of the gear in the 30 ft. boats appears relatively consistent. Where it can get confusing is with the 25 ft. emergency cutters. The appearance of the gear in these boats even varies from both forward to aft in these boats.

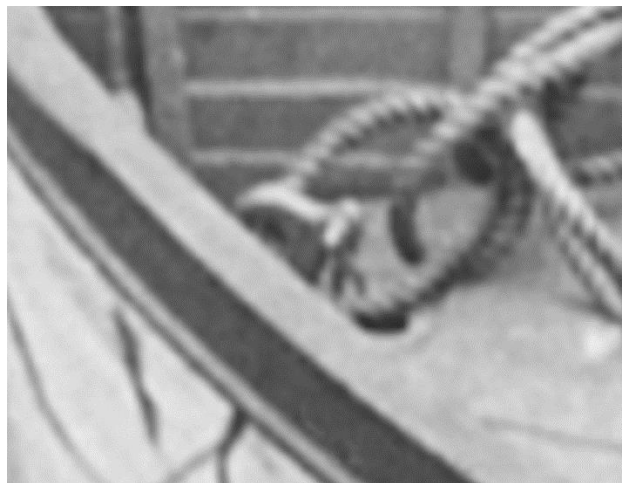
What we see in Figure 2 is a hook which faces toward the end of the boat. There is a hinge on the side of the hook facing toward the center of the boat. Directly below the hinge is a releasing hook presumably which would be pulled downward to release the disengaging hook from its locked position so that it could rotate in a clockwise direction so that the eye at the end of the fall block could slide free. Drawings will be provided in the next section to explain both the structure and the operation.

The next aspect of the photos to be examined is the apparent difference between the gear seen in the 30 ft. main lifeboats as seen Figure 2 and those seen in the 25 ft. emergency lifeboats as seen in Figures 6, 7, and 8. If you compare these gear, what one notices is that the fork which

holds the axle for the hook on the 25 ft. boats has its tines spaced fairly widely apart. For some time it was difficult to reconcile the appearance of these with those seen in Figure 2. Figure 8 began to offer some clues. As we can see in this photo, there is a chain shackle fixed from the fall block through the tines of the gear's fork. What I believe this shows is why the tines of the 25 ft. boat gear needed to be wider. The 25 ft. emergency boats were always suspended in the falls. They did not rest on chocks. With this constant strain on the gear, there needed to be a safety measure to prevent damage to the boat if the gear would accidentally disengage. The way this was accomplished was by a chain shackle where the chain attached to the block and rove through the hook and its axle so that if the hook accidentally disengaged, the weight of the boat would be borne by the chain. The fact that there were two different variations of the Murray's gear was confirmed by a search for documents relating to the gear in the British National Archives. Figure 9 is the Log book which referenced the two designs of the Murray's gear. Design A referred to the gear for the 30 ft. main lifeboats and Design B referred to the

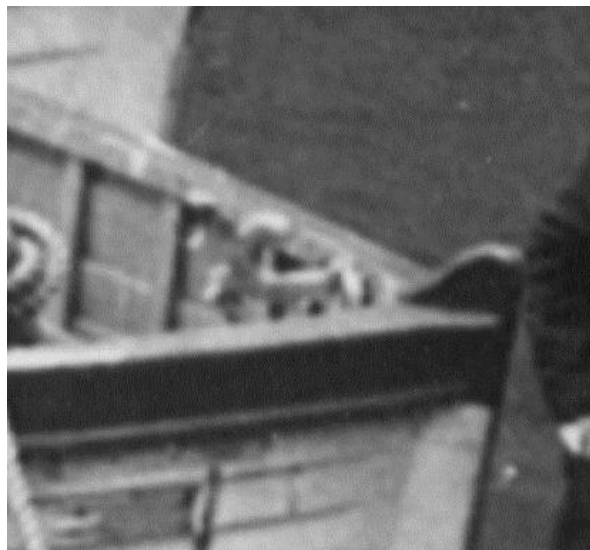
Figure 3

The next best photo example (Figure 3) is of the forward end of a 25 ft. emergency cutter. In this photo we see the disengaging hook rotated counterclockwise roughly 90 degrees from its locked position.

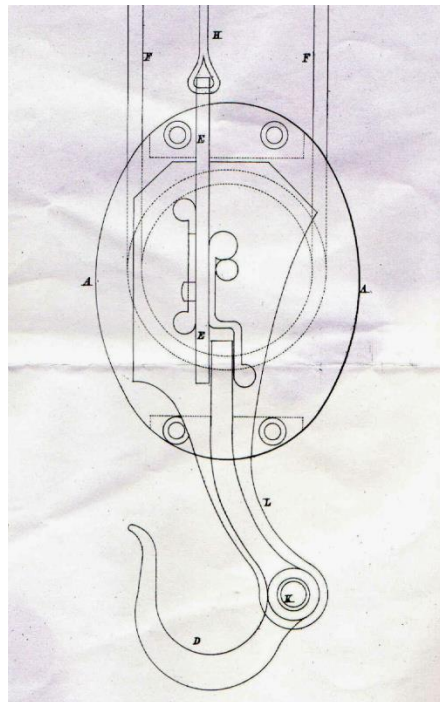
Figure 10 is a scan of Murray's original 1866 patent for boat disengaging gear. The main design difference is that the disengaging gear is an integral part of the lower fall block. This early design does have some elements which influenced the later design. The later design kept the rotating hook except that now the hook rotated on an axle between the tines of a fixed fork attached to the boat.

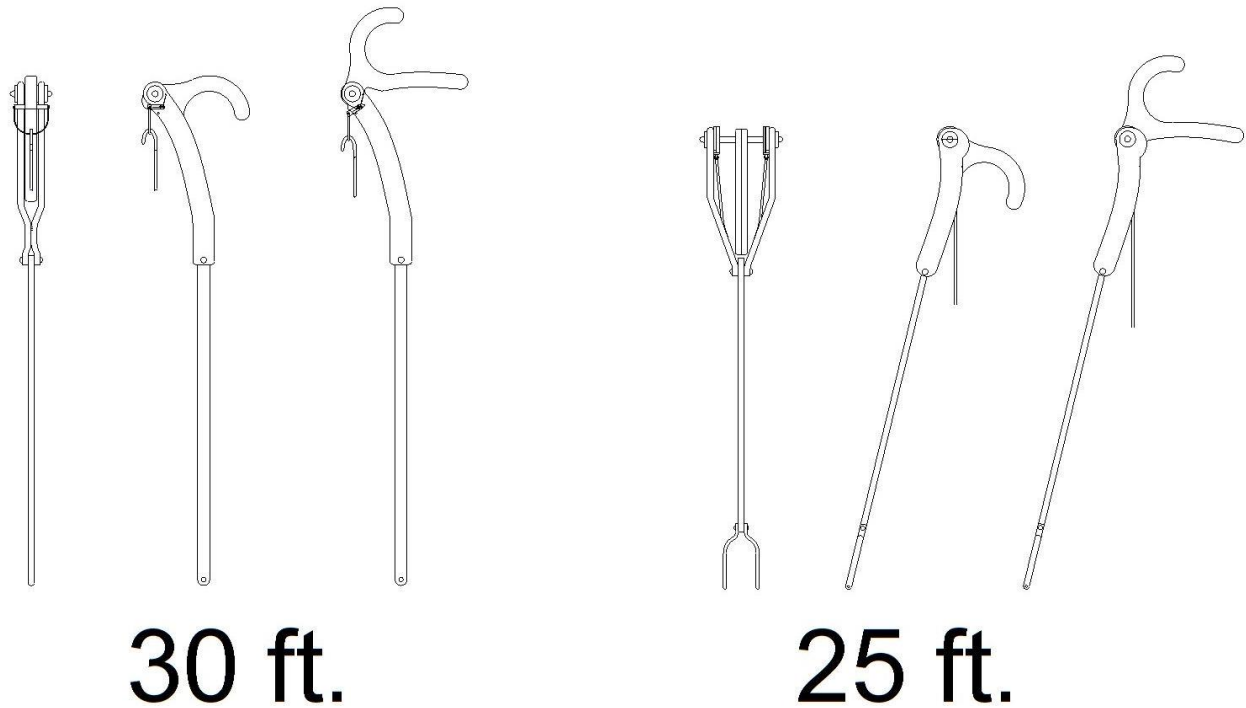
Figure 11 has a number of drawings showing the configuration of the disengaging gear for the 30 ft. and 25 ft. boats. There are both an end view and a lateral view in both drawings. These drawings show the gear in its locked position. The far right drawings show the gear released when the locking mechanism is pulled downward by the releasing hook which is attached to the releasing mechanism.

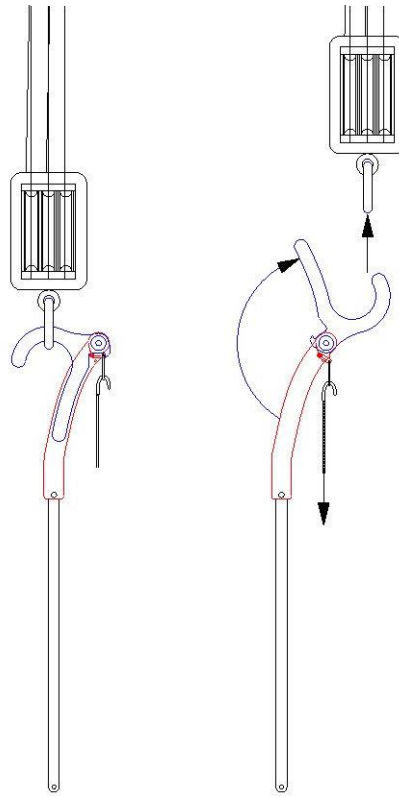
In Figure 12 we see an illustration of the release of the disengaging gear from the falls. The disengaging gear hook attaches to an eye at the bottom of the lower fall block. When the releasing mechanism's rod pulls down on the releasing hook attached to the latch mechanism, the disengaging hook is unlocked and released. It is able to rotate and release from the eye in the fall block which allows the boat to fall away from the falls and be free to maneuver.

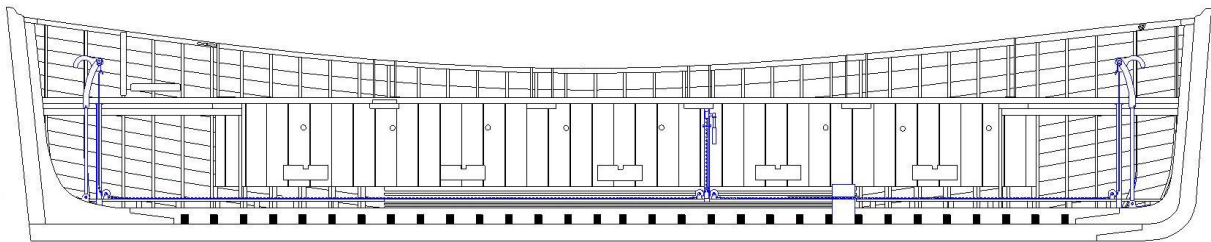
Figure 13 is a longitudinal cross section of a 30 ft. main lifeboat. The positions of the disengaging and releasing gear are shown in blue.

Figures 14, 15, and 16 are enlargements of the pertinent areas of figure 13. Figure 14 is the aft end of the boat. Figure 15 is the forward end of the boat. Figure 16 is the mid area of the boat showing the location of the releasing handle.

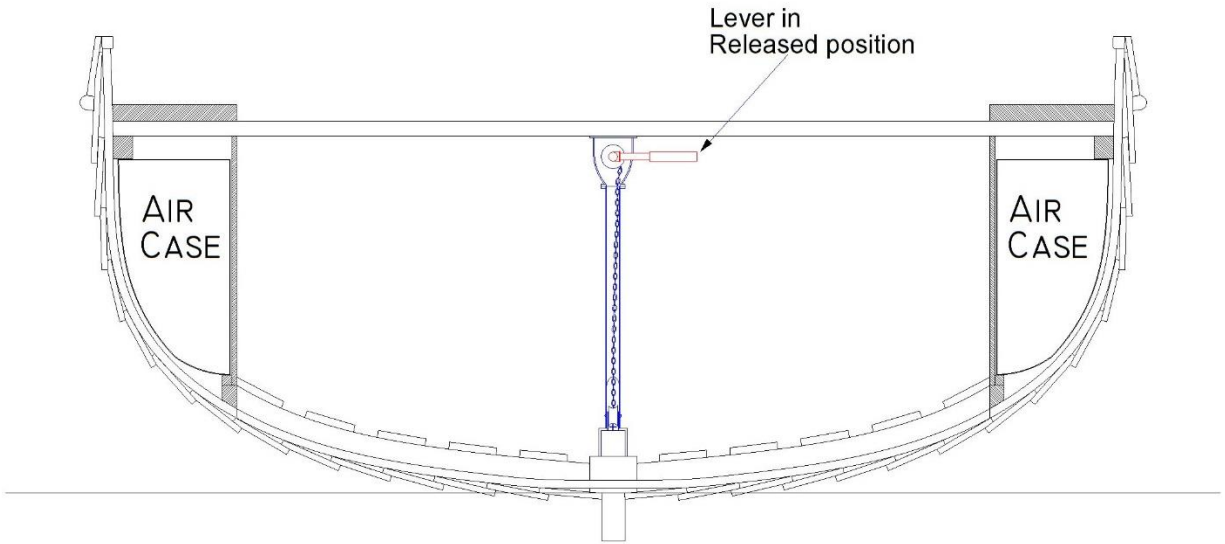
Figures 17 and 18 are cross sections across the breadth of the 30 ft. boat near the releasing lever. The positions for the locked and released positions are indicated. The lever was placed on the forward side of the thwart because those rowing would be facing aft. During rowing operations the lever would be behind the rower and would not interfere with the rowing function.

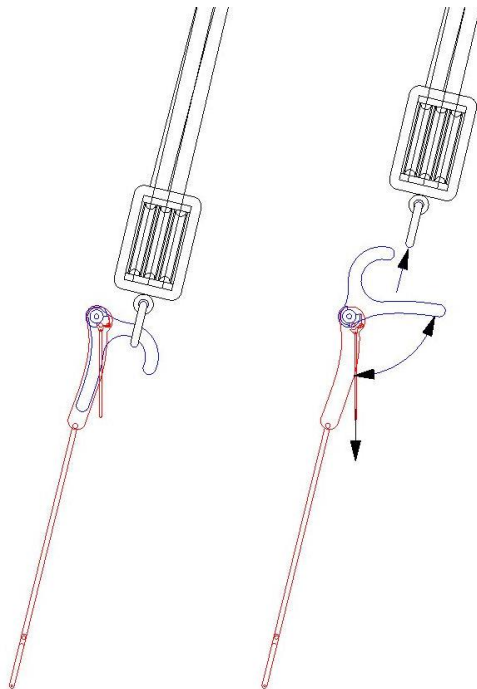
In the next series of drawings, the configuration of the alternate design of “Design B” of the Murrays device for the 25 ft. emergency cutters will be examined. In the Photos section, the existence and reason for a modification of the design of the gear for the 25 ft. boats was discussed. Figure 19 illustrates the operation of the gear for the 25 ft. boats. This gear is angled toward the ends of the boat. Its operation is similar to that of the gear for the 30 ft. boats as shown in figure 12 except that the pull on the gear is not straight upward as with the 30 ft. boats. Rather, the gear has to be angled to accommodate the davits which are spaced to accommodate the 30 ft. boats.

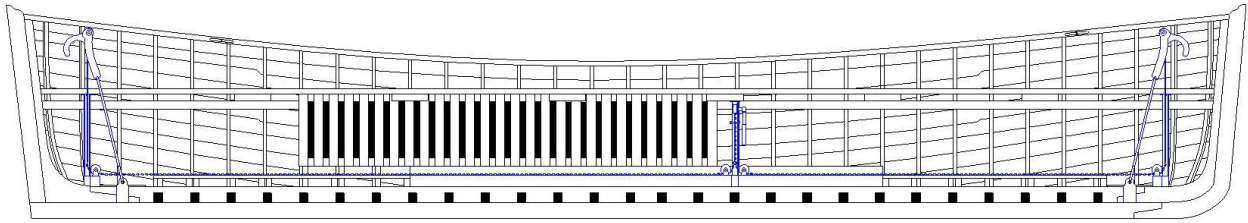
Figure 20 illustrates the gear for the 25 ft. boats in a longitudinal cross section.

Figures 22, 23, and 24 are enlargements of the pertinent areas of Figure 20. Figure 22 is the aft end of the boat. Figure 23 is the forward end of the boat. Figure 24 is the mid area of the boat showing the releasing lever.

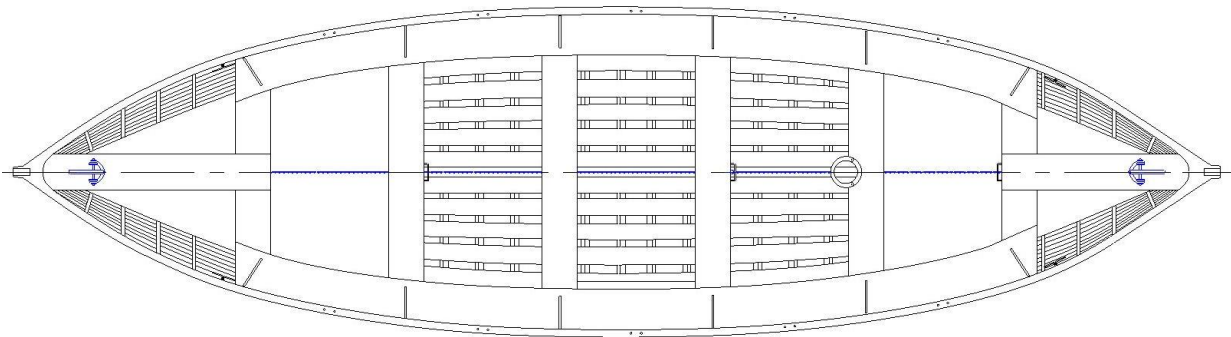
Figure 21 illustrates a plan view of one of the 25 ft. boats.

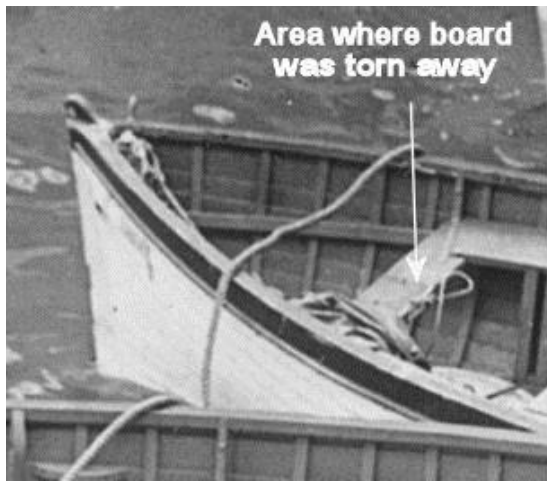
Recently an observation was made which helped explain some of the discrepancies seen in the 25 ft. boat disengaging gear. Figure 25 is an enlargement of the aft area of one of the 25 ft. boats. I have placed an arrow pointing to an area on the aft thwart which is a different color. What this indicates is where a fore and aft board attached to the aft thwart. Figure 26 shows the outline of where this board would have been before the board was torn away. The disengaging gear on the 25 ft. boats was angled to accommodate the spacing between Titanic's davits. Probably when this boat was being hoisted aboard R.M.S. Carpathia, the boat was being hoisted in such a manner that the force on the disengaging gear was vertical rather than at its

designed angle. This tended to lift the fore and aft board away from its fastening. After this board was gone, the disengaging gear now is not held in its designed position but falls toward the aft end of the boat as we see in the photo. This discrepancy hindered accurate interpretation of the set-up of the disengaging gear on the 25 ft. boats for some time.
