Documentation of a New *Titanic/Olympic* Find: Support Stanchions Under the Poop Deck

By Bob Read, D.M.D.

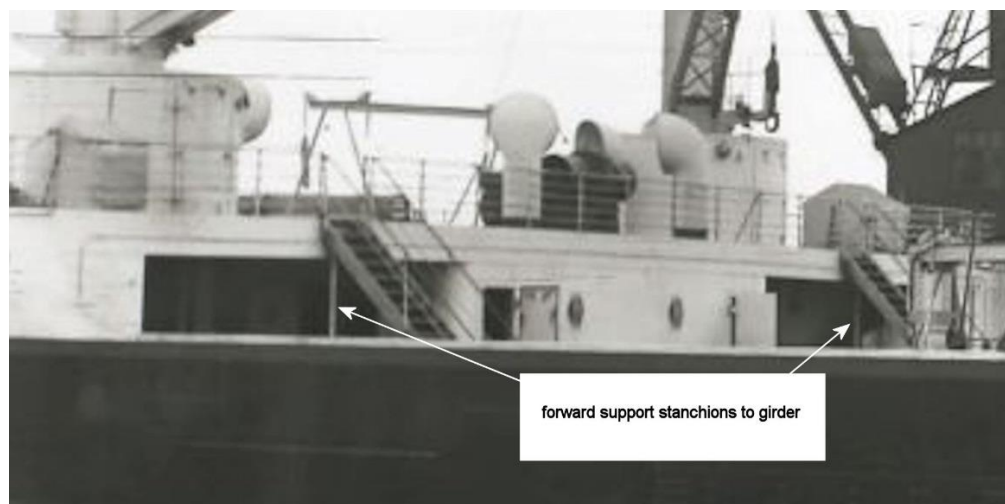
Figure 1

The first photo in which the original discovery was made is shown in Figure 1. Arrows point to the stanchions which were originally discovered.

Support stanchions under forward poop deck

It is not often that new structures are discovered relating to *Titanic/Olympic*. Fortunately on April 26, 2019 Alexey Chekaev posted such a new find on the Facebook group [RMS Titanic Model Research and Tech](#). The discovery was made in a Getty photo of *Olympic*. In the photo is seen what appears to be stanchions at the fore end of the underside of the poop deck just aft of the stairways. The reason these structures were never discovered before is because there were very few photos taken at such an angle as to reveal these stanchions. After examining other photos, two additional stanchions were discovered. This article is being written to document this discovery because retrieving such material from Facebook forums is not easy. This article will give an explanation of the discovery and provide easy access to it in the future.

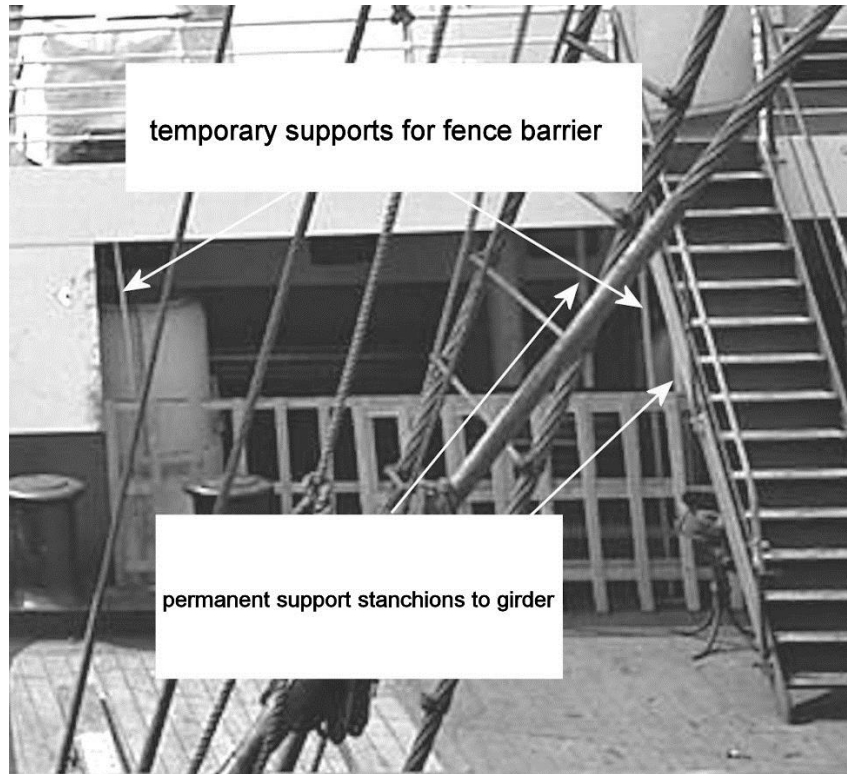
Figure 3 is another photo which shows the same structures from a slightly different angle.

Permanent support stanchions to poop deck girder
