Titanic's Chart Room and Pilot's Room Windows

By Bob Read, D.M.D.

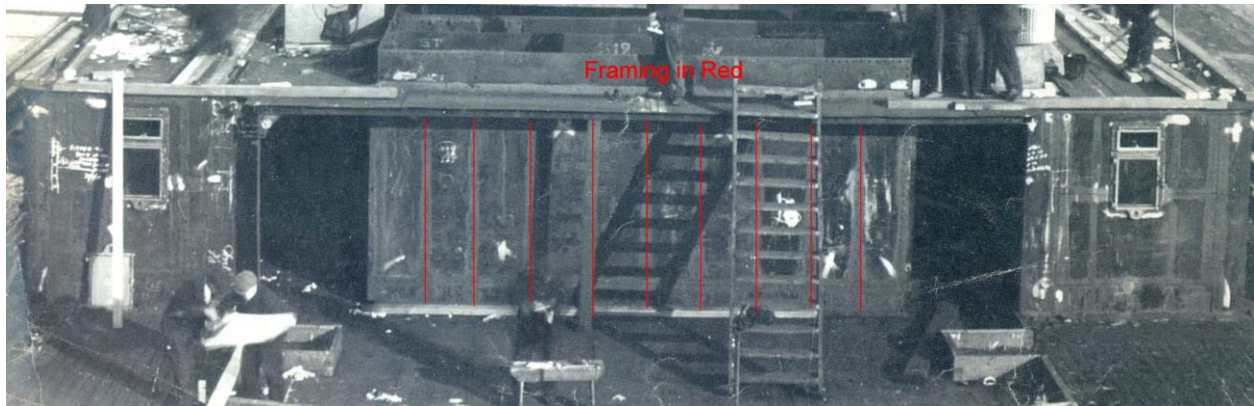
Figure 5

With these three windows opening into the fan trunk the next task was to analyze how they were arranged. The chart room and the pilot's room occupied a space which was 20 ft. wide. The chart room was 12 ft. wide and the pilot's room was 8 ft. wide. The fan trunk into which these windows opened was 12 ft. wide. Windows through bulkheads always are placed between underlying framing. In order to determine the placement and even the size of the windows we needed to determine the framing of this aft bulkhead between the fan trunk and the chart room and pilot's room. The way we were able to determine the framing was by examining an *Olympic* fitting out photo shown in Figure 5.

In looking at the photo we see that a smoothing compound was placed over the frames where they were flush riveted. The underlying frames are indicated in red. On this 20 ft. wide bulkhead it is evident that there are 10 spaces between frames. This means that the frame spacing was 24 inches. Using known dimensions of the fan trunk and those of the chart room and pilot's room, the layout of the windows was drawn in Figure 6. It can be seen in this drawing that given the width of the fan trunk and the spacing of the windows in the photos that only three windows could be placed within the area of the area of the fan trunk. They could be shifted one frame to starboard from what is seen in the drawing but the photos seem to suggest that the arrangement shown in Figure 6 is correct.
