# The Case for a Change in the Color of Titanic's Cargo Hatch Coamings

By Bob Read, D.M.D.

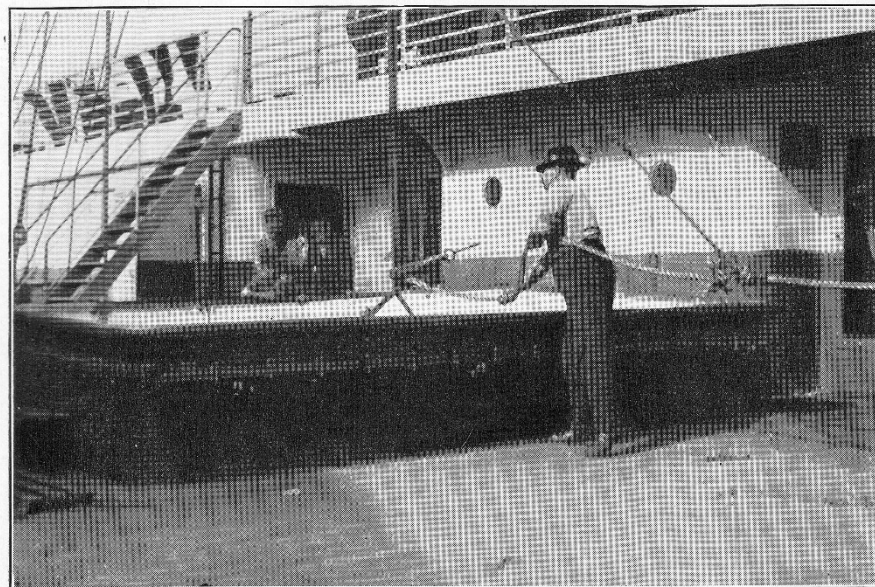
Figure 5

The problem that this presents is that is that if the exterior of the cargo hatch coamings were, in fact, black then it would be almost impossible to distinguish them from the dark mast dados near them. Fortunately, I recently discovered improved quality photos taken of Olympic's forward well deck during cargo operations. The photos were taken from a book called "The Longshoremen". They were taken in bright sunlight which improved the quality of the photos. Because of some structural changes made to Olympic's original configuration, I would date this photo as most likely being post-Titanic disaster sometime in the middle of 1912. Figures 4 and 5 show two of the pertinent photos. It is clear in these photos that the shade of the hatch coaming of cargo hatch #2 is darker than the dark mast painted forward well deck dados.

Throwing the burton hook; an exhibition of skill. The hatch coamings are sufficiently high to afford some protection

### Comparison of hatch coaming and dark mast dado

One difference with the Britannic Specification Book is that the interior of the hatch coaming is white rather than dark mast. Probably when Olympic's hatch coamings were raised during her 1913 refit, the interiors were repainted dark mast but I don't have any photo evidence of this. However, this does not change the photo evidence that the exteriors of the hatch coamings were visibly darker than the dark mast dadoses and were most likely black. It is also clear in the photos that the interior was painted white at the time of Titanic in 1912.
