The Controversy Over the Paint Remnants on *Titanic's* Recovered Officers' Quarters Window

By Bob Read, D.M.D.

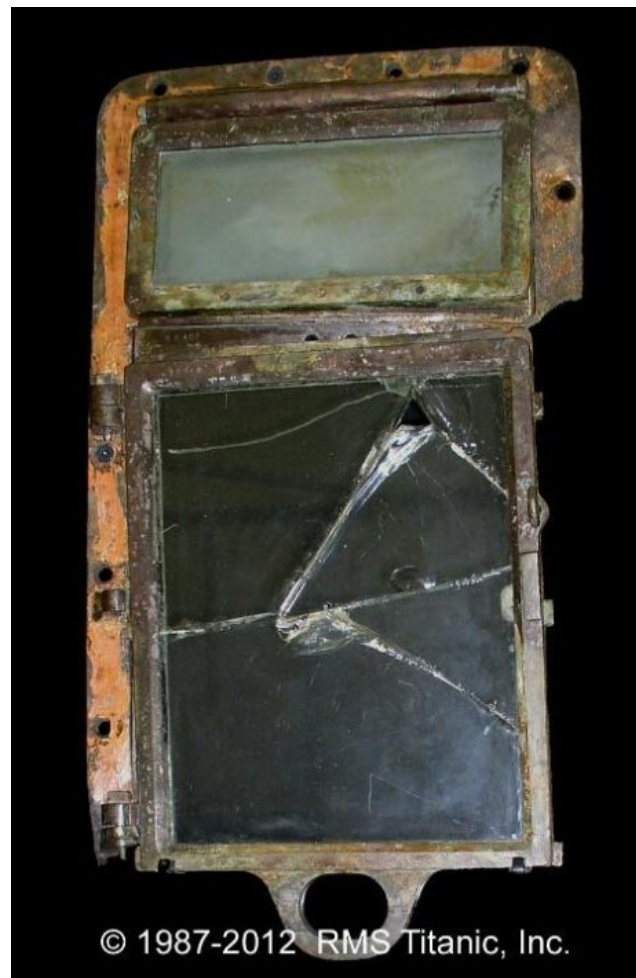
Figure 1

Titanic's recovered officers' quarters window

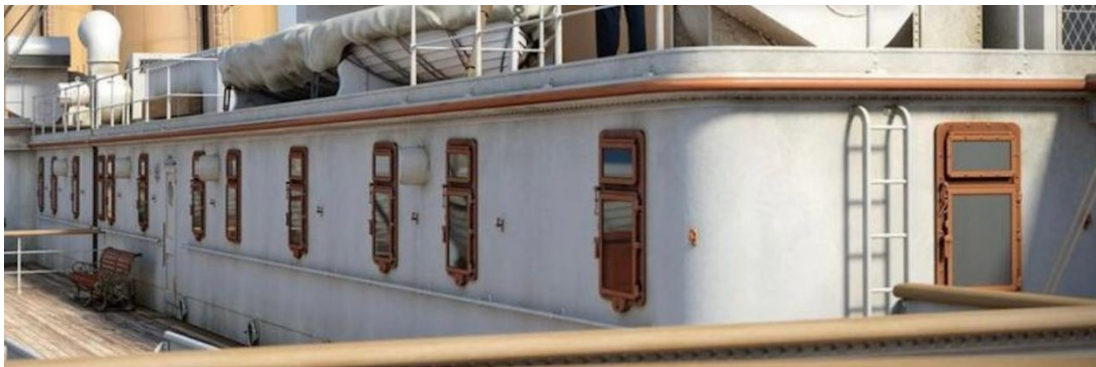
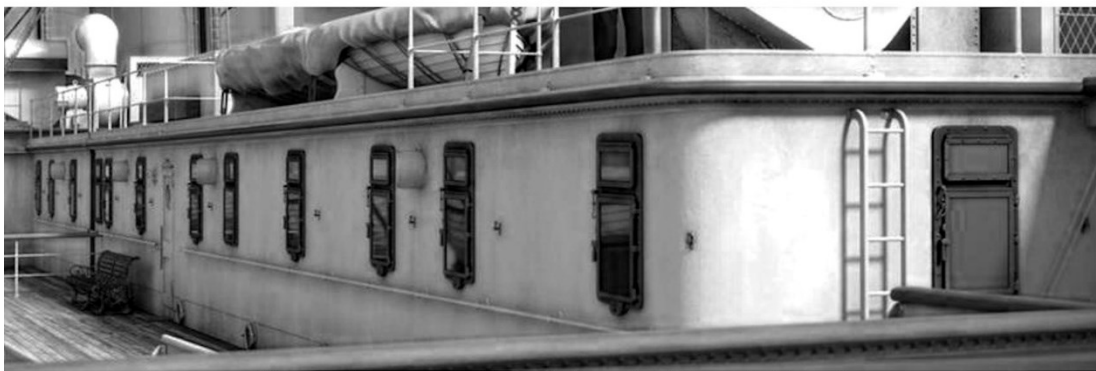
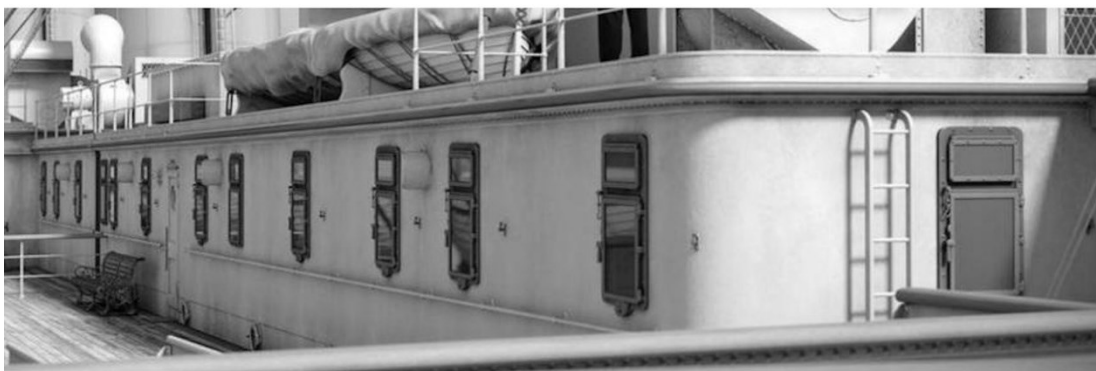
color image

orthochromatic black & white image

panchromatic black and white image

Comparison of different types of photographic film

This digital image was made by digital artist Vasilije Ristic. The first black and white image below the color image is a representation of how an orthochromatic black and white film image would appear. The bottom image is a representation of how modern panchromatic black and white film would appear.

The black and white photos taken of *Titanic* were taken with orthochromatic black and white film. Some of the characteristics of this type of black and white film are that it makes reds, yellows, and oranges appear very dark and it makes blues look very light. Modern

panchromatic black and white film does not have these drawbacks. Figure 4 shows a digital image of *Titanic's* officers' quarters with the window frames painted with the "dark mast" color.

I believe that the misjudgment that the color “dark mast” could not appear as dark as it does in orthochromatic black and white photos has led some to believe that the paint remnants on *Titanic’s* recovered officers’ quarters window couldn’t be the final color coat of paint. Therefore, they had to have an explanation for the color of the paint remnants. All they could do is declare that it was actually red oxide primer then look for examples of shades of red oxide which they believed were close to the shade of the paint remnant on the window. This analysis did not start with which color the remnants matched but rather that the remnants didn’t match the darker color in black and white photos. Therefore, they had to define the paint remnants as being red oxide then find uncommon shades of it as proof.
