An Analysis of One of *Titanic's* Vent Trunk Intakes

By Bob Read, D.M.D.

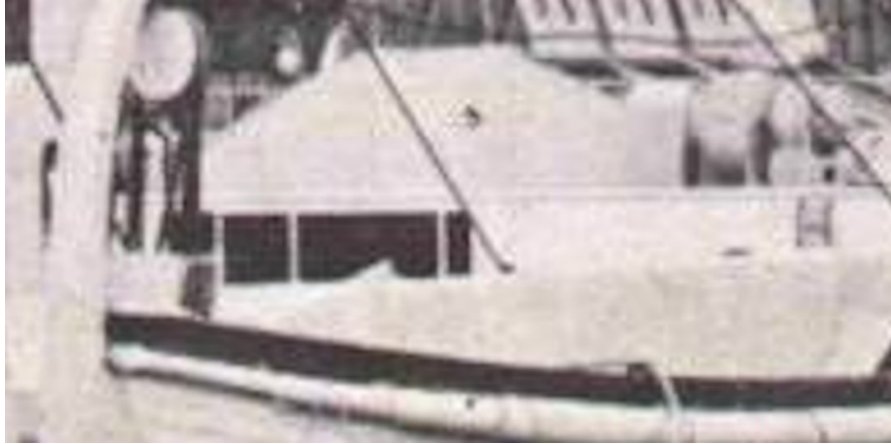
Tank room vent trunk intake 1913

Figure 5 show the tank room vent trunk intake in 1913.

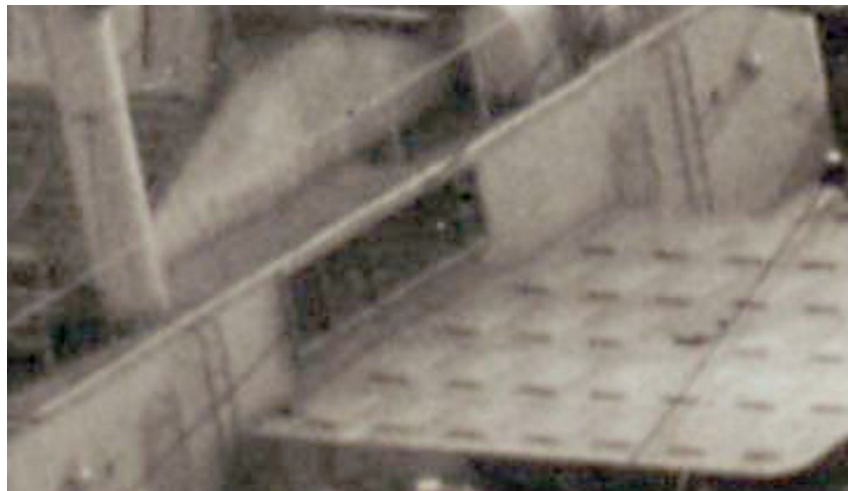
Tank room vent trunk intake during WWI

Figure 6 shows a more unobstructed view of the tank room vent intake during WWI.
