# A New Understanding of the Positions of the Welin Boat Davits Aboard Olympic and Titanic

## Introduction

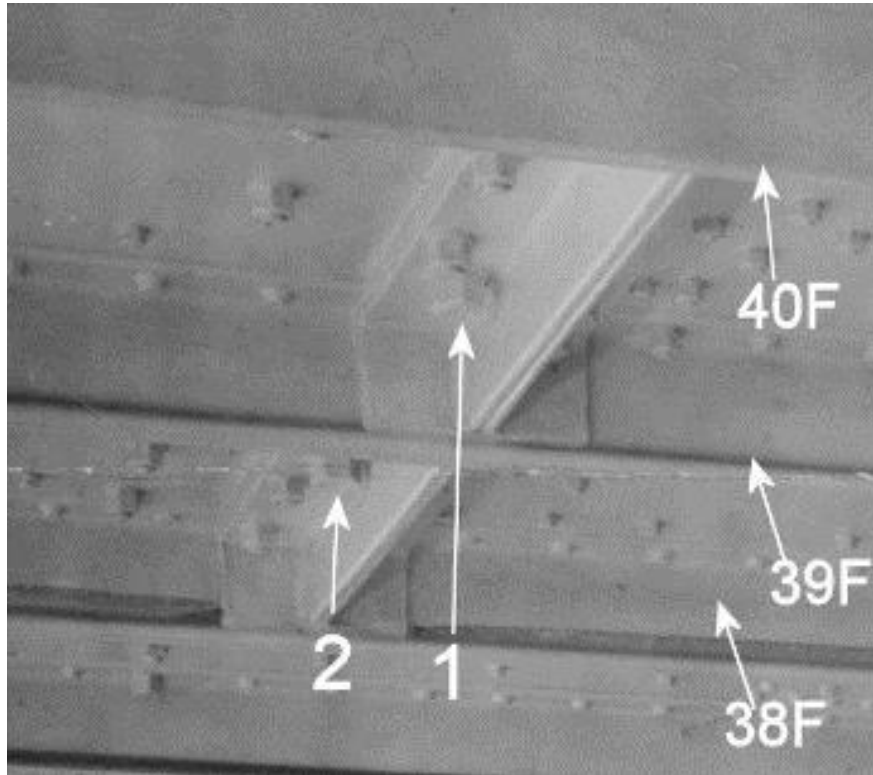
Figure 1

The term “carling” is used in shipbuilding to describe a short longitudinal deck beam used between transverse deck beams. In Fig. 1 we see a photo taken from Olympic’s promenade deck looking up at the underside of the boat deck.

The carlings flank the deck beam at frame location 39F. These carlings are simple angle iron. They are doubled to form a “T” cross section and are joined by brackets to the transverse bulb angle deck beams.

In Fig. 1 there are only two large davit bolts and nuts visible which are labeled “1” and “2”. This area is under the inboard end of the boat davit. The other smaller bolts visible are for the boat bitts, fairlead, and water hydrant. For the sake of simplicity these will not be labeled. The two bolts and nuts visible are on the outboard side of the carlings. They are bolts which pass through the outboard row of holes in the inboard foot of the twin frame davit base. The bolts

through the inboard row of holes in the inboard foot of the davit frame are not visible because they are obscured by the vertical aspect of the carling.

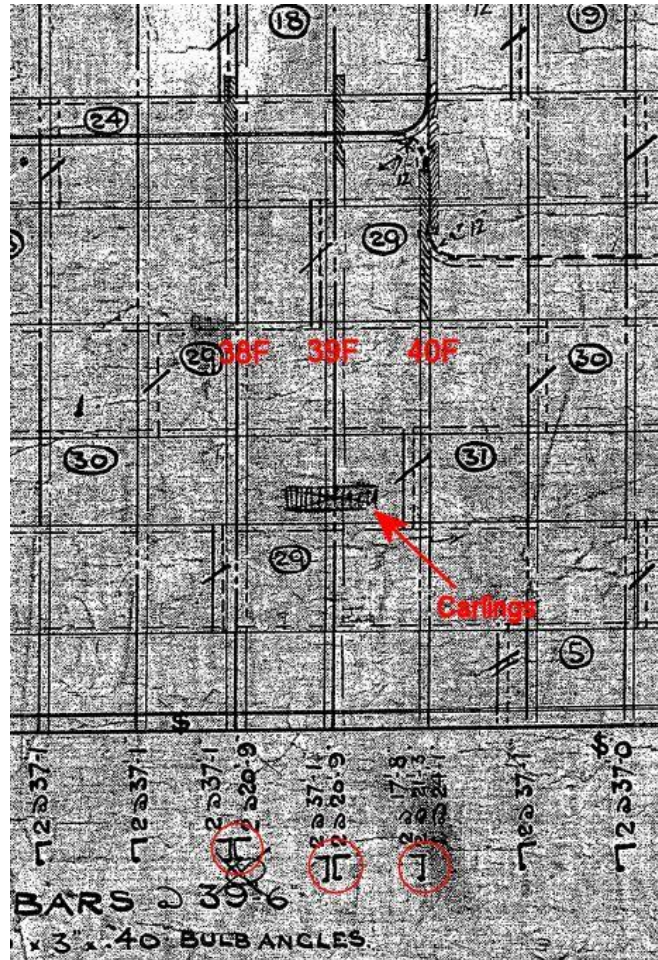
Figure 2

Fig. 2 shows this area of the Harland and Wolff original Boat Deck Iron plan where the carlings flanking the deck beam 39F are added to the plan in pencil.

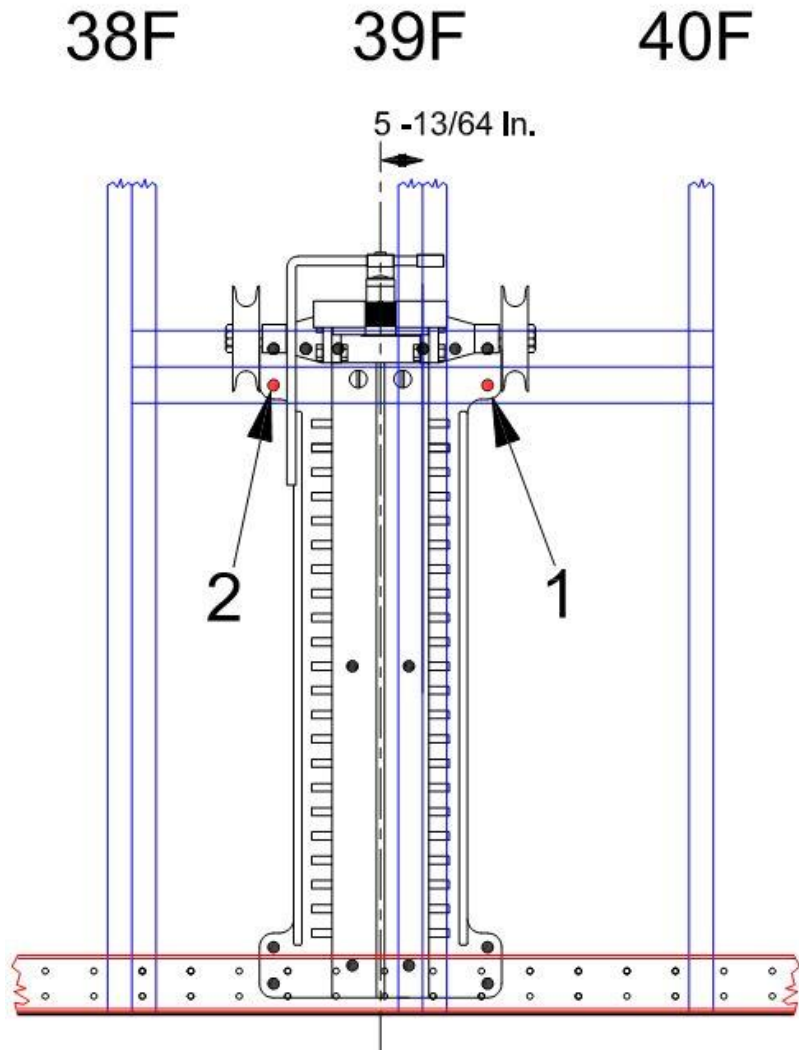
Figure 3 shows a drawing of the area. The bolts 1 and 2 shown in Fig. 1 are indicated in this drawing. The locations of other bolts which pass through the carling and deck beam are shown. It must be remembered that not every hole in the davit foot was used. This has been confirmed by photos.

In this drawing we can see that the davit is positioned aft of the center of beam 39F which is where it was originally thought to be centered. The drawing was produced in AutoCad so we are able to measure distances with precision. Additionally we have accurate dimensional plans of the davit frames and dimensions of the deck beams. With this information we are able to determine the fore and aft location of the davit frame with a high degree of precision. Using all

this information, I believe the davit frame was shifted 5 – 13/64 in. aft of beam 39F. The reason that a fraction of an inch in 64ths is given is because of the thickness of the vertical aspect of the bulb angle beam must be compensated for in centering bolt holes on the horizontal beam face.

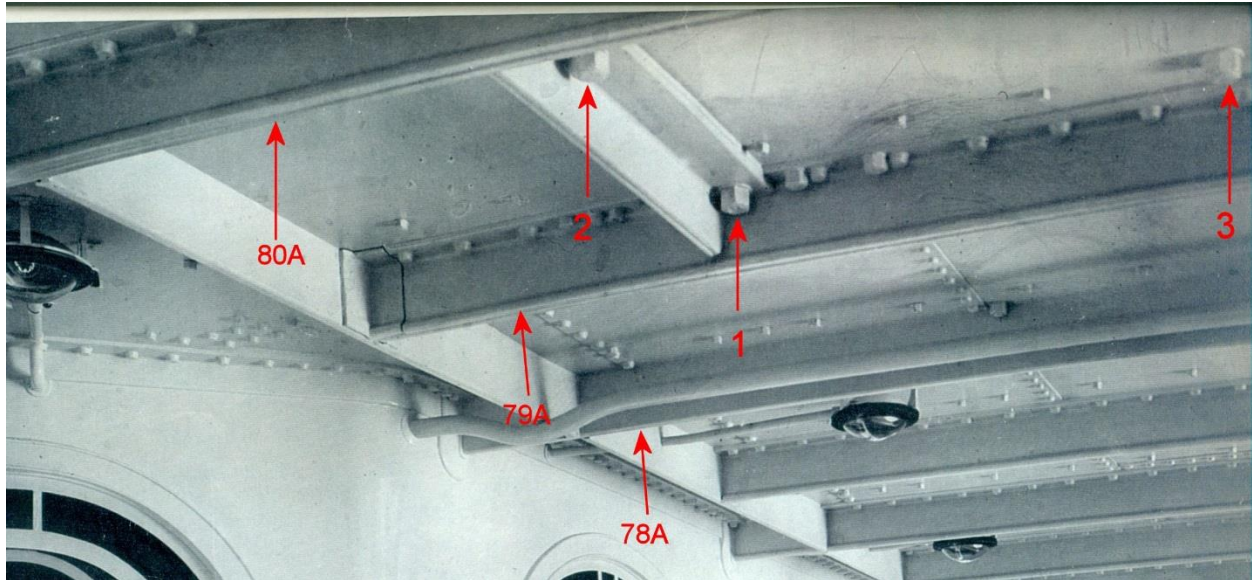
Figure 4

In Fig. 4 we are aft on Olympic's promenade deck looking up at the underside of the boat deck.

The beam locations and davit bolts and nuts are labeled in the photo. Fig. 5 shows this location on the Boat Deck Iron plan where the single carling is located aft of the deck beam at 79A. Fig. 6 is a drawing showing how the single frame davit was positioned in relation to beam 79A. The center of the davit was shifted aft of frame 79A by 13-37/64 in.

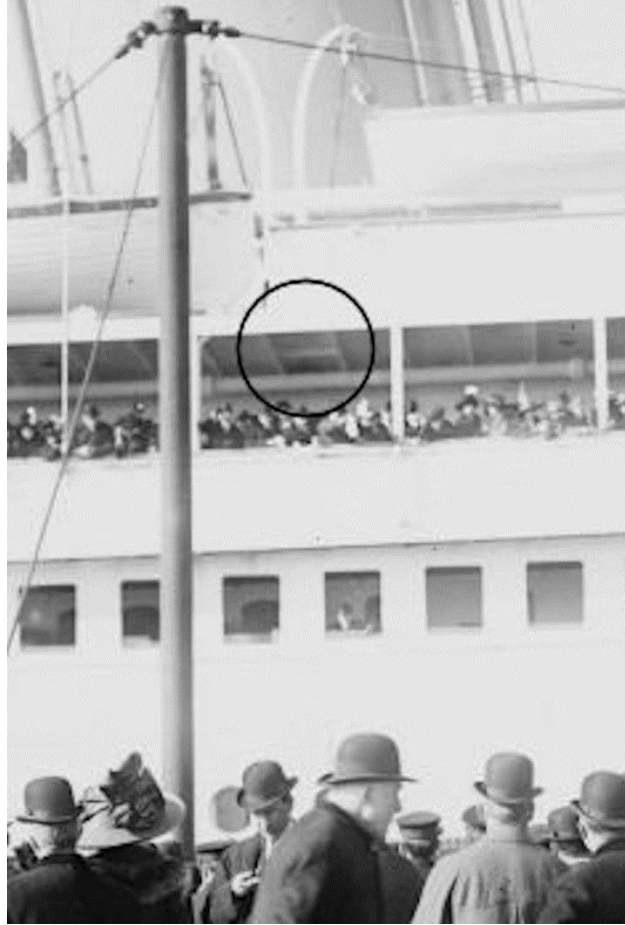
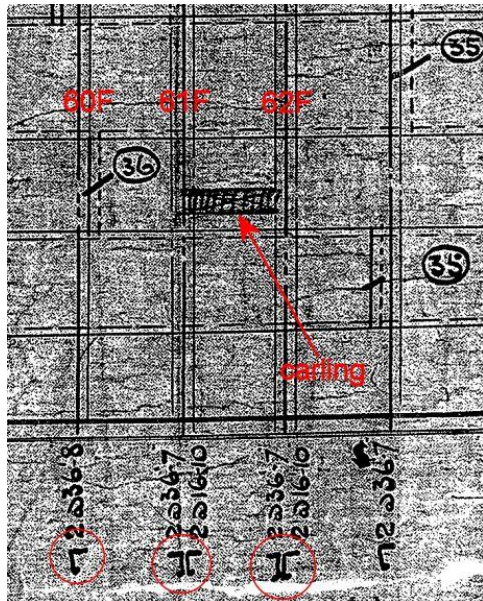
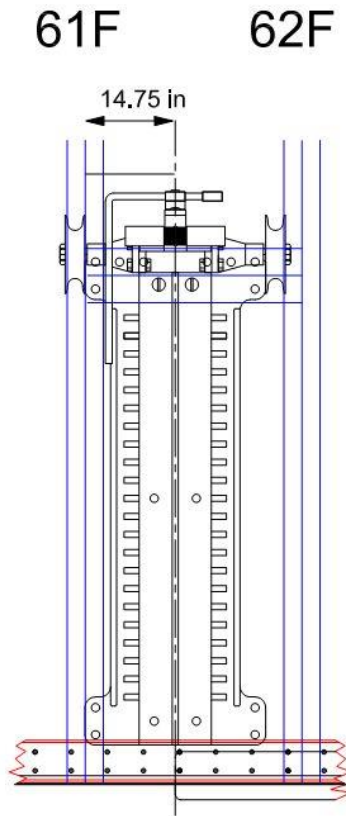
The only other davit with a single carling under it is the twin frame davit near the beam at 61F. Figs. 7, 8, & 9 show this single carling set-up in a photo, in the Boat Deck Iron plan, and in a drawing. The davit is shifted 14-61/64 in. forward of the deck beam at 61F. I can't give any readily apparent reason why this particular davit was set up over a single carling. I have some ideas but at this point I am hesitant to speculate as it serves no real purpose here.

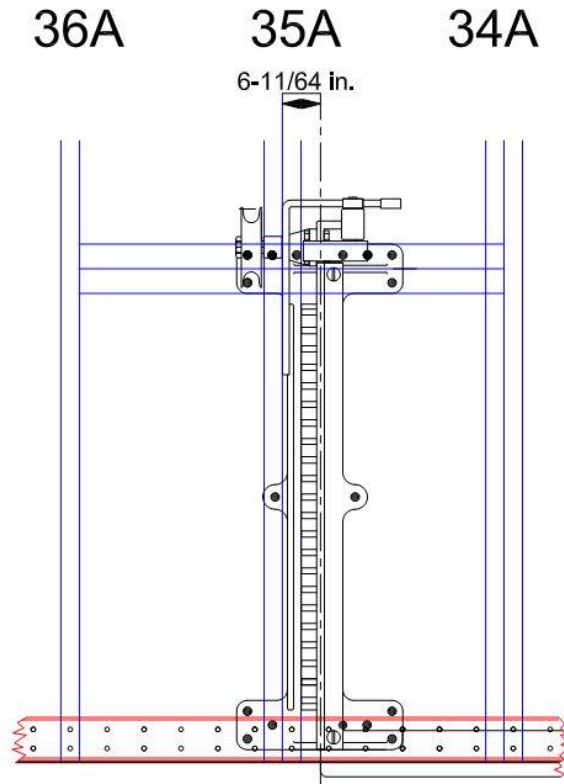
There are two locations where single frame davits are mounted over double carlings. These davits are found at frames 35A and 28F. Because of the double carlings beneath these davits, they are positioned differently than the other two single frame davits positioned over single carlings. Figure 10 shows the positioning of the davit at 35A. It is shifted 6-11/64 in. forward of the deck beam at 35A. The single frame davit at 28F is shifted the same distance aft of the deck beam.
