# A New Understanding of the Positions of the Welin Boat Davits Aboard Olympic and Titanic

## Introduction

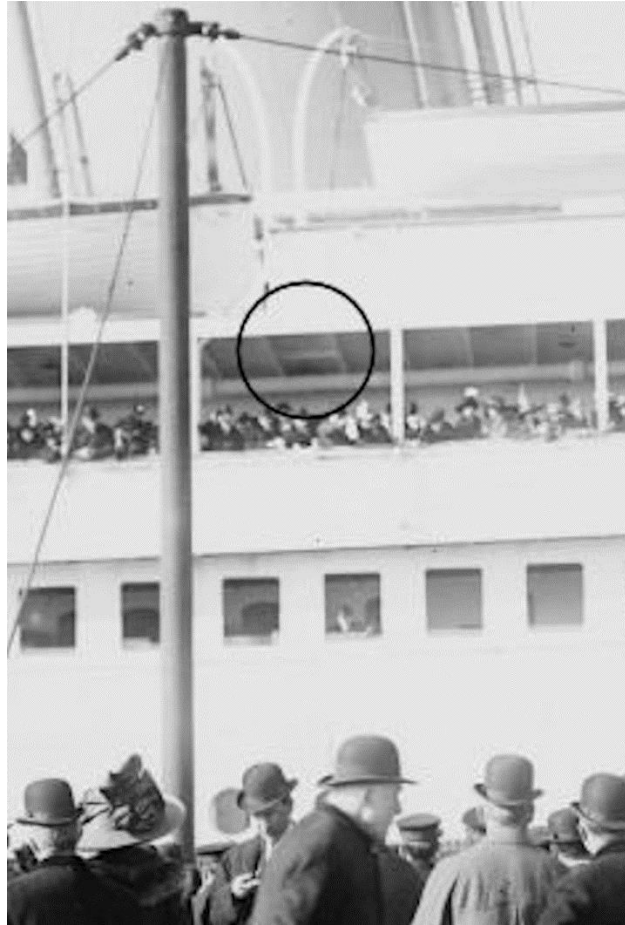
Figure 7

The only other davit with a single carling under it is the twin frame davit near the beam at 61F. Figs. 7, 8, & 9 show this single carling set-up in a photo, in the Boat Deck Iron plan, and in a drawing. The davit is shifted 14-61/64 in. forward of the deck beam at 61F. I can't give any readily apparent reason why this particular davit was set up over a single carling. I have some ideas but at this point I am hesitant to speculate as it serves no real purpose here.
