Titanic's Bridgefront Windows

By Bob Read, D.M.D.

This article will describe the structure and operation of the nine windows forward of *Titanic's* navigating bridge. The proposed internal structure and function of these windows will be discussed.

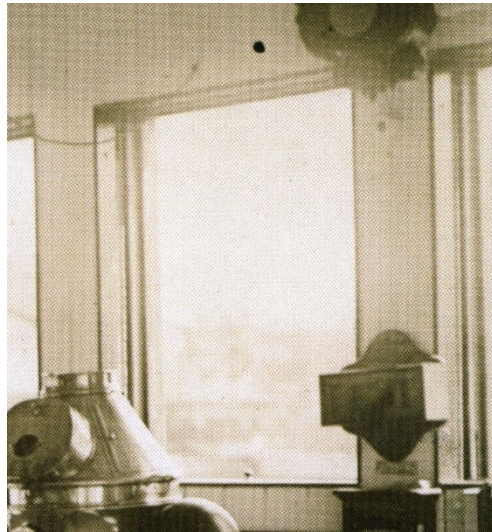
Interior view of bridgefront windows in open position

The windows are in their raised and closed positions. When the windows were opened, they were lowered into the bulkhead below them like a pocket window. Figure 3 is a photo of Olympic's bridge showing the windows in the open position.

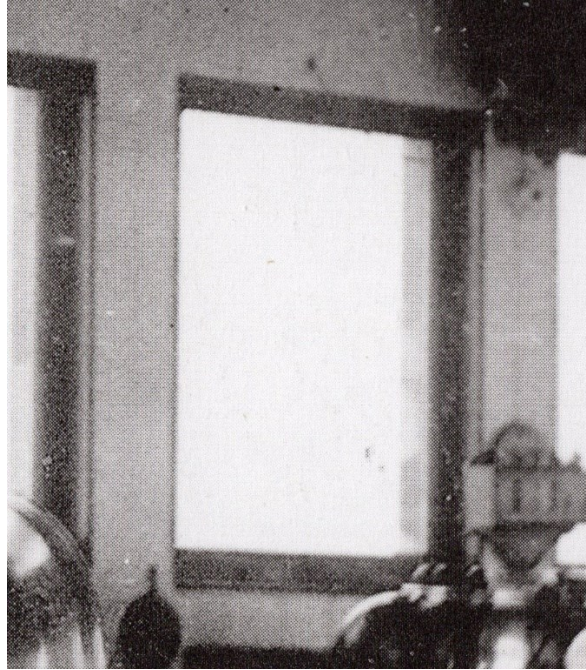
Interior view of bridgefront window in closed position

Figure 4 is an interior view of a bridgefront window in the closed position.

The windows appear to be common framed sash windows in construction. Because of the need to isolate the bridge compasses from any kind of ferrous metals, any metals used in their construction are non-ferrous. There were only a few construction items which needed to be non-ferrous metal. In Figure 5 we see lead sash weights.

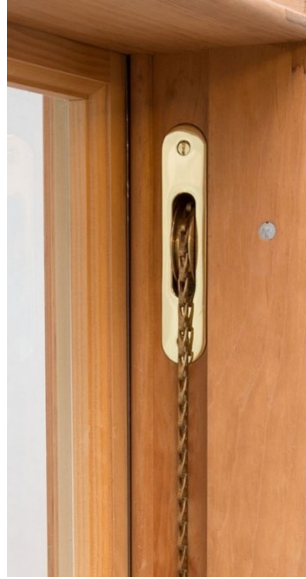
Figure 5

Brass chain and sheave

In Figure 6, a brass chain and sheave is shown.

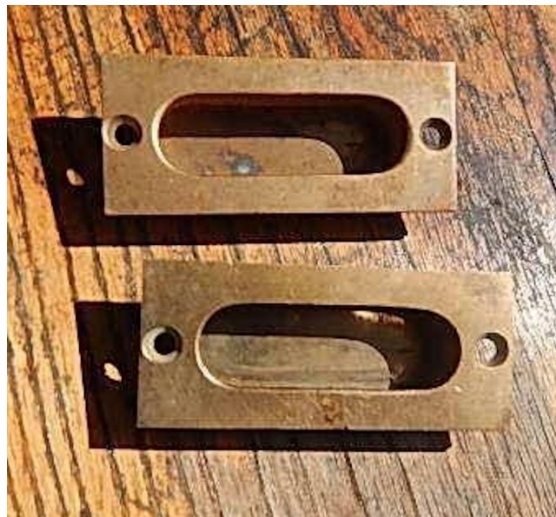
Brass finger pulls

Finally, in Figure 6 we see representative brass finger pulls.

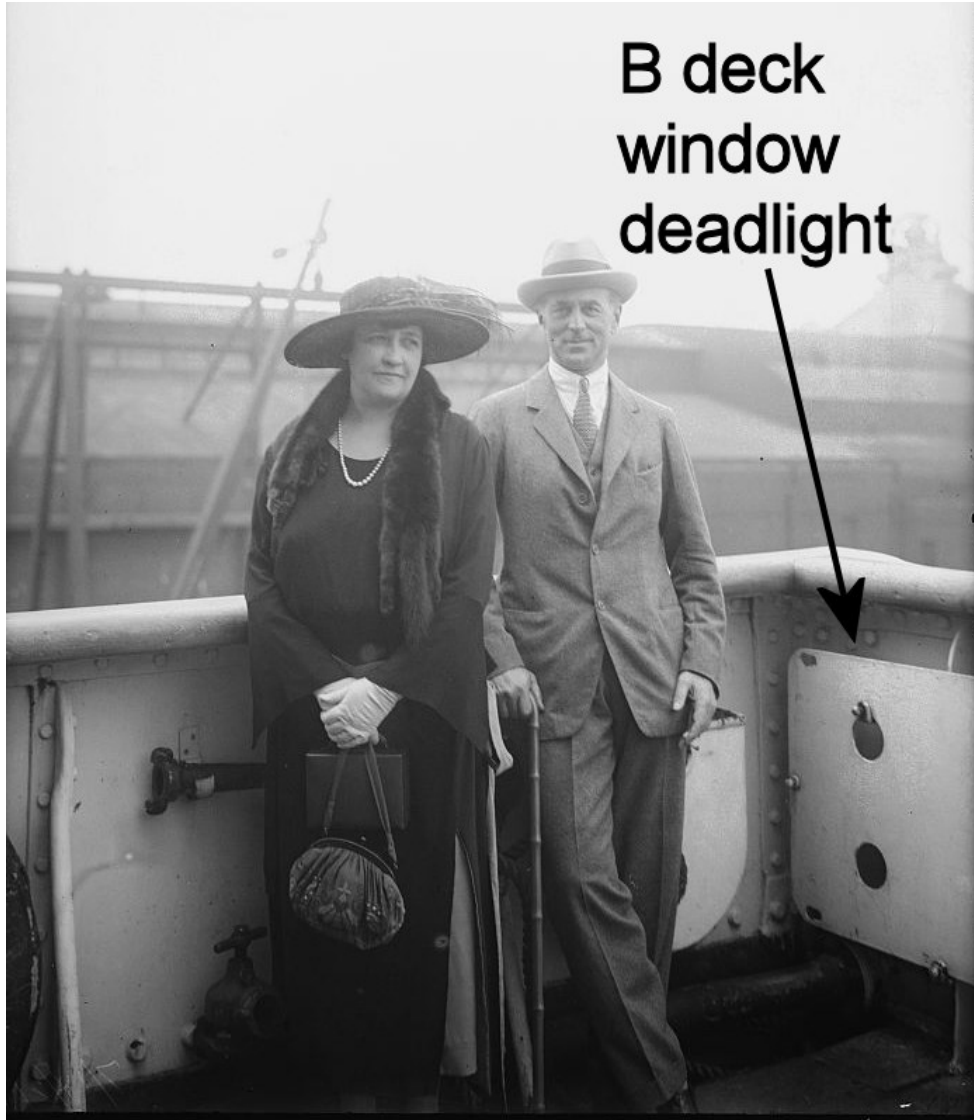
Figure 13

Forward B deck window skylight stowed on bulwark

The purpose of a deadlight is to protect a window from storm damage. For the forward B deck windows, steel deadlights were stowed on the inboard side of the forward bulwark. These were rigged on the outside of the B deck forward windows. Part of one of these can be seen in Figure 13,
