A Re-Examination of the Structures on the Forward Roof *Titanic's* Fourth Funnel Deckhouse

By Bob Read, D.M.D.

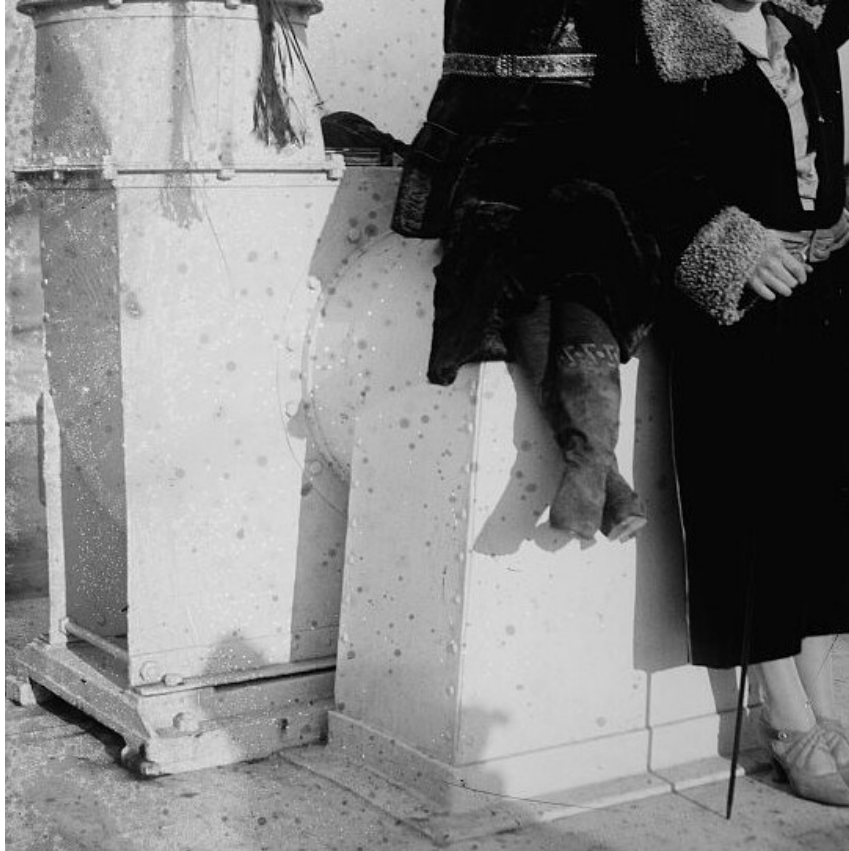
Figure 2

Standard deck duct for 20-inch ventilator

I attempted numerous duct transition attachments to skylights and they didn't seem to agree with photos. I believe the reason is because I was trying to use the *Olympic* method of connection to the skylights. In a moment of insight, it occurred to me that a standard 20-inch duct connection to the deck could easily be adapted for use with the skylights. This type of duct is shown in Figure 2.

This type of duct makes a 90-degree angle from the ventilator intake downwards. I believe this type of duct could be adapted by cutting its lower aspect to match the slope of the upper aspect of the skylight shown in Figure 3.

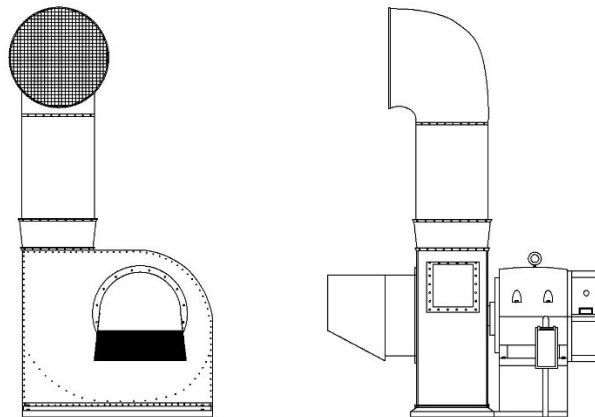
Figure 3

20-inch ventilator with modified standard deck duct
