The Rationale for the Modification of Three of *Titanic's* Ventilators

By Bob Read, D.M.D.

There were three particular ventilators on *Titanic* which had their intake ducts modified in comparison to any found on her sister ship *Olympic*. The purpose of this article is to describe these three ventilators, the modifications which were made to them, and the proposed rationale for making these changes.

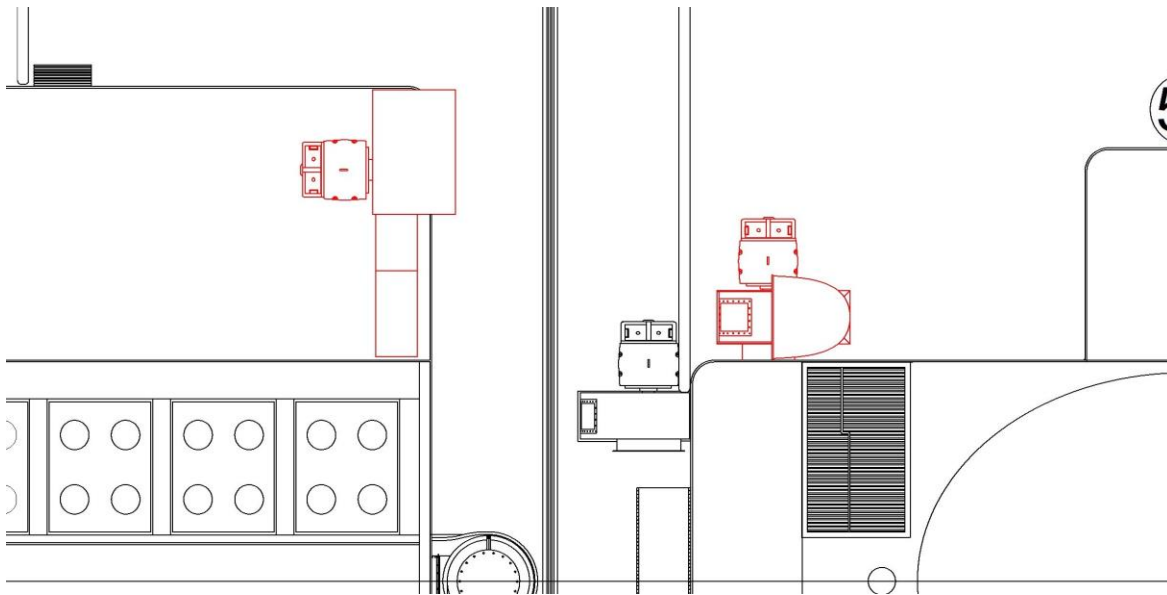
Figure 8 is a plan view of this ventilator showing the proximity of the cowled sirocco fan which exhausted forward of it.

Plan view of 35 in. sirocco fan with modified swan neck intake

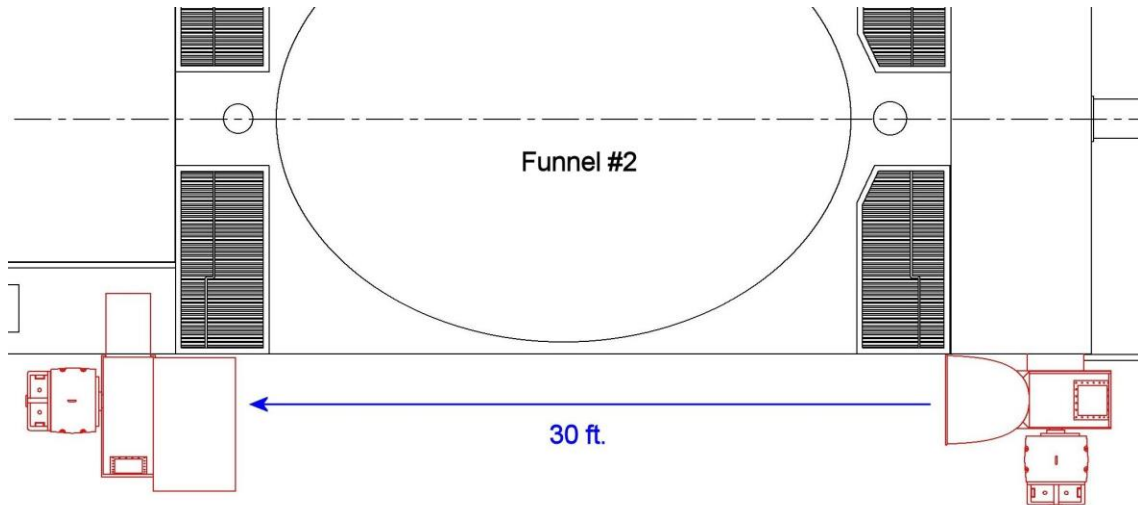
One might look at other ventilator configurations and suppose that there are exceptions to the rule that on *Titanic* they avoided close proximity between upwind sirocco fans with cowl exhausts and downwind delivery sirocco fans with forward facing intakes. The first situation like this we will examine is the 30 inch sirocco fan with cowl exhaust forward and starboard of the second funnel. Downwind of it is a 35 inch sirocco delivery fan with a forward facing swan neck intake. Figure 10 is a plan view of these two ventilators.

Plan view of ventilators on starboard side of funnel #2

Since the 35 inch sirocco fan with a swan neck intake was modified, we can surmise that the 30 ft. distance between it and the sirocco with cowl exhaust forward of it was of sufficient distance to prevent excessive exhaust from being drawn into the aft ventilator with the swan neck intake.
